# Manhole Inspection Summary

Manhole # S130\_\_004MH

Insp Date: **12/9/08 8:16 AM**

**Location** Address: **Rear of 501 S. Longwood St**

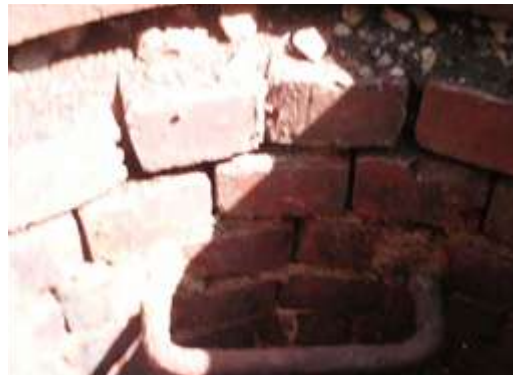
Defect 2

Condition: ☐ Sound ☐ Cracked ☐ Root Intrusion ☒ **Loose Brick** ☐ Deteriorated

loose bricks missing mortar

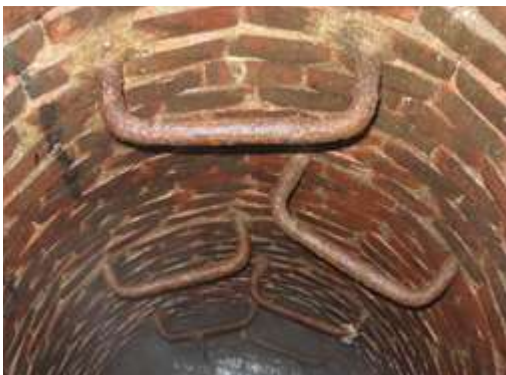
Defect 1

Count: **7** Missing: **0** ☒ **Corroded**

oxidized rungs

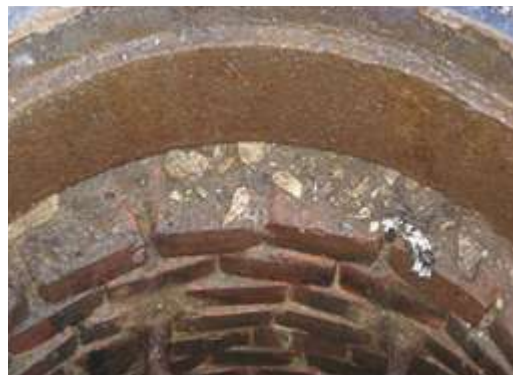
Defect

Offset: **3** (in.)

Condition: ☐ Sound ☐ Cracked ☒ **Leaks**

frame leaks, offset
